The Locomotive

THE HARTFORD STEAM BOILER
INSPECTION AND INSURANCE CO.

VOL. XXXVIII

HARTFORD, CONN.
1930-1931

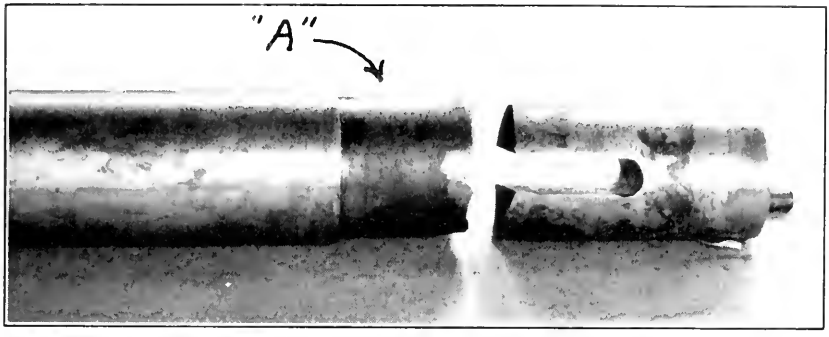
Figure 1

A case in point, where a dismantled inspection would have been very useful, is illustrated by the accompanying photographs showing the result of and the apparent reason for a progressive failure in a piston rod. Figures 1 and 2 show respectively the broken piston rod and the endwise views of the fracture. The latter show clearly the characteristics of a crack which progressed slowly until only the small, dark area at the left of Figure 2-a and the corresponding dark area at the right of Figure 2-b remained unbroken.

It is evident that the rod had been flexing a small amount, and that this first caused a slight surface overstress. In time the surface crack penetrated the rod, thus reducing the area of sound metal to a point where there was not enough left to withstand the normal load stress. From an examination after the accident it was apparent that the fit of the rod in the crosshead left much to be desired, the rod being tight only at its extreme end. This condition can be seen in Figure 1, the bright area near the end showing where the rod fitted tightly, and the dark area "A" near the shoulder giving evidence that there had not been a proper fit at that point. Of course, this was what allowed the flexing and the subsequent failure.

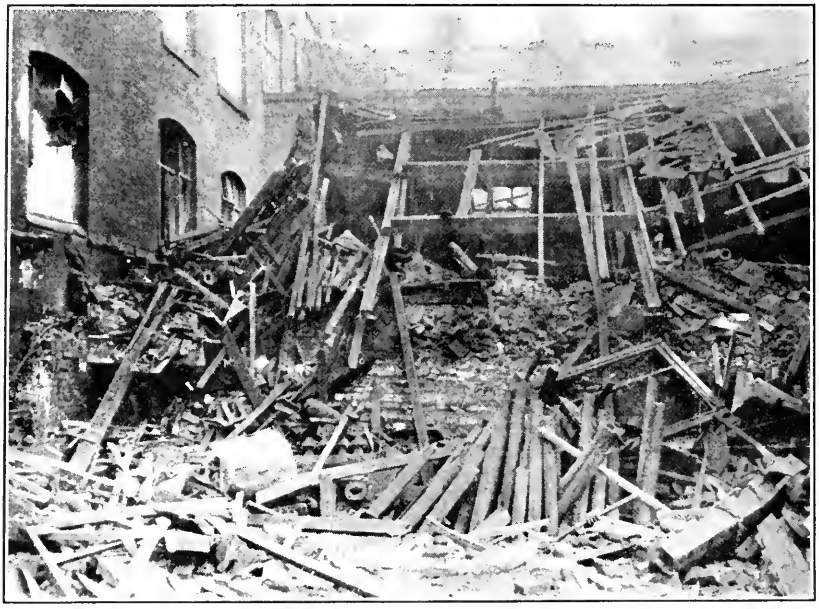
FAULTY manipulation of the dampers and feed line valves on an economizer of the ordinary cast iron type recently caused a very serious explosion that not only destroyed the apparatus itself but wrecked the building housing it. The accompanying illustration is a photograph of the wreckage.

and there was no chance for a circulation of water through it, the hot flue gases started to generate steam which overheated the metal and probably caused serious expansion stresses at the joints between the tubes and the upper header. The explosion occurred about half an hour after the fires were stirred up. It is suspected that even though the gases were by-passed around the economizer during the night, there may have been enough leakage past the damper to keep the tubes fairly hot, so that steam was quick in forming after the full supply of flue gas was shunted through the apparatus.

An examination of the fractured tubes showed that many of them had been affected internally by graphitic deterioration. Wall thickness

was generally well maintained but at some points the greater part of the cast iron seemed to have been converted into a graphitic structure. At places this graphite had broken away from the tubes, leaving a very much reduced thickness of good cast iron. Undoubtedly, this change in the nature of the material had taken place over a long period, for the economizer was twenty-five years old.

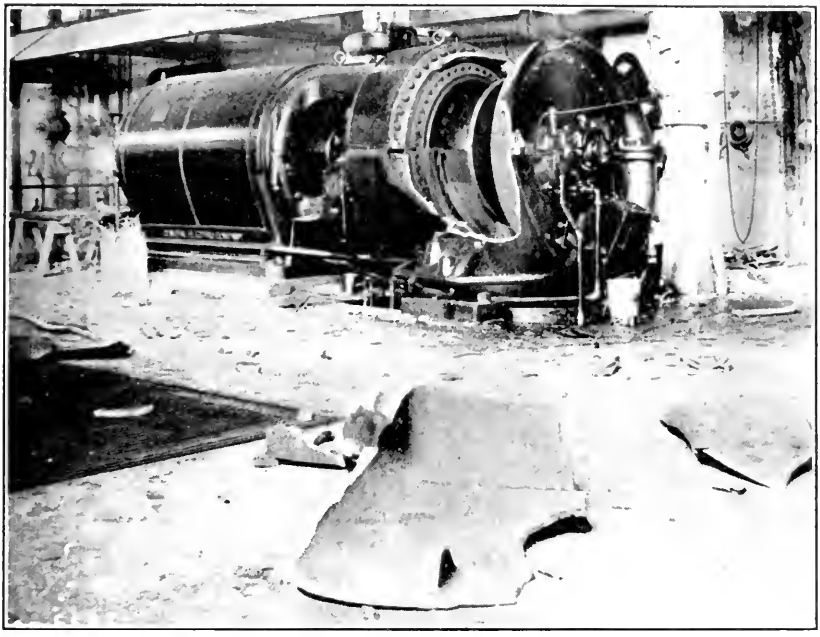
Figure 1

A 3,000 kw. turbo-generator at the Akron, Ohio, plant of The Quaker Oats Company exploded without warning on September 20th, 1929, when a third-stage rotor disc burst while the machine was running at normal speed. (See Figure 1.) The watch engineer had a narrow escape from death or serious injury, for only two or

The initial rupture was in a diametrical direction across the keyway and through one of the balancing holes in the disc. There was also

a break in the disc rim extending through about a third of the circumference, but this failure evidently occurred subsequent to the other.

From the appearance of the broken disc (shown in Figure 2) it seems probable that there was progressive failure over a considerable period of time at a point immediately adjacent to the keyway. This broken area showed a silky fibre not in evidence on the roughly torn portion of the surface where rupture was evidently instantaneous. Although the progressive crack may have existed for some time prior to the accident, it was located on the inner side of the disc at a point where an inspector could not gain access.

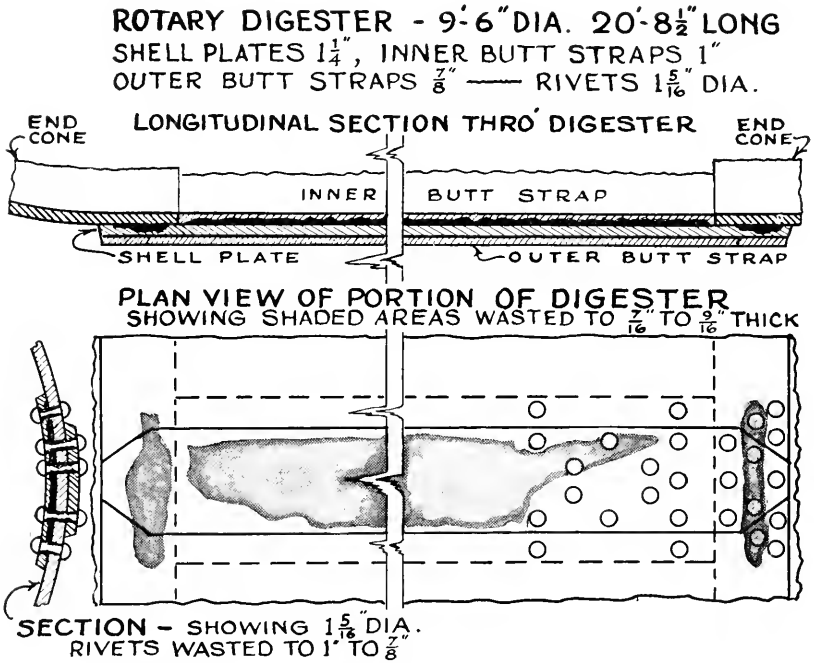
Figure 2

ROTARY DIGESTER - 9'-6" DIA. 20'-8½" LONG
SHELL PLATES 1¼", INNER BUTT STRAPS 1"
OUTER BUTT STRAPS ⅞" —— RIVETS 1 5/16" DIA.
END CONE
LONGITUDINAL SECTION THRO' DIGESTER
END CONE
INNER BUTT STRAP
SHELL PLATE
OUTER BUTT STRAP
PLAN VIEW OF PORTION OF DIGESTER
SHOWING SHADED AREAS WASTED TO 7/16" TO 9/16" THICK
SECTION - SHOWING 1 5/16" DIA.
RIVETS WASTED TO 1" TO ⅞"

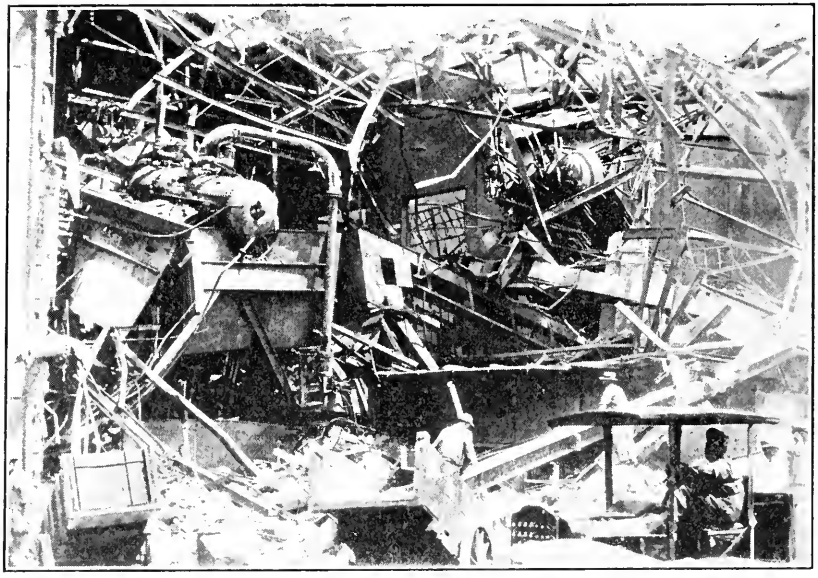
Boiler No. 6 exploded. The seam opened up the entire length of the drum and both heads blew out. Figure 1 shows a portion of the plant after the explosion. Boiler No. 5 was knocked out of its setting

and badly damaged. When two of the remaining boilers were subjected to hydrostatic tests, they were found to be badly cracked. The cracking took place from rivet hole to rivet hole in the riveted areas. Examination of the fine incipient cracks showed them to be typical embrittlement cracks.

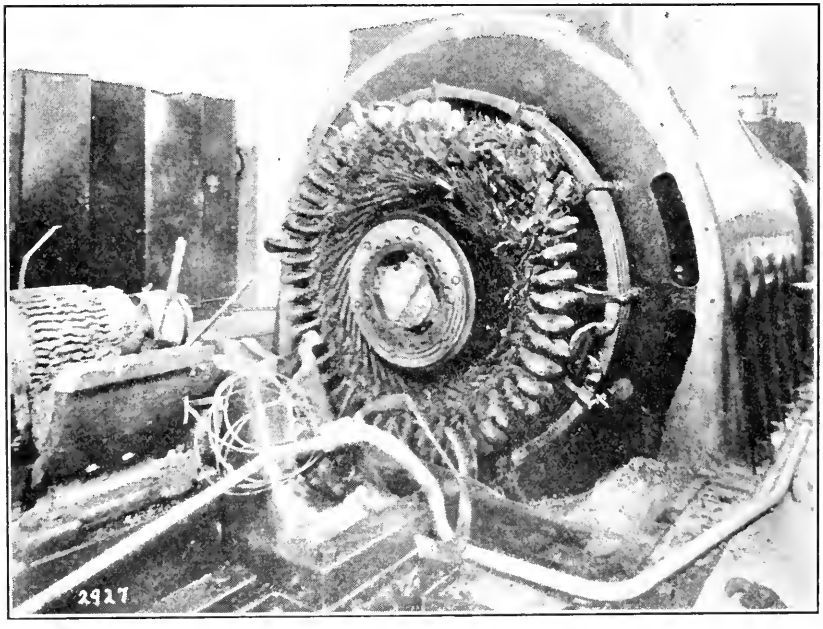
Figure 1

A VERY disastrous turbo-generator explosion occurred on October 7th, 1929, at a power plant in Texas. A 6,000-kw. machine was so badly damaged that only the turbine casing and the generator frame could be salvaged. The owners were reimbursed to the extent of $25,000, the limit at which the unit was insured, but the total loss was over $80,000.

The machine had been in operation about one year during which the generator had given periodic trouble because of a tendency to vibrate when starting or whenever there was a sudden, large change of load. However, the unit was running smoothly just before the accident. From the appearance of the rotor it was clear that overspeed had been a prominent factor in causing the wreck, but it is thought possible that vibration may have contributed in that it could have caused the shaft to "whip" seriously when the turbine reached a critical speed after the load was suddenly lost.

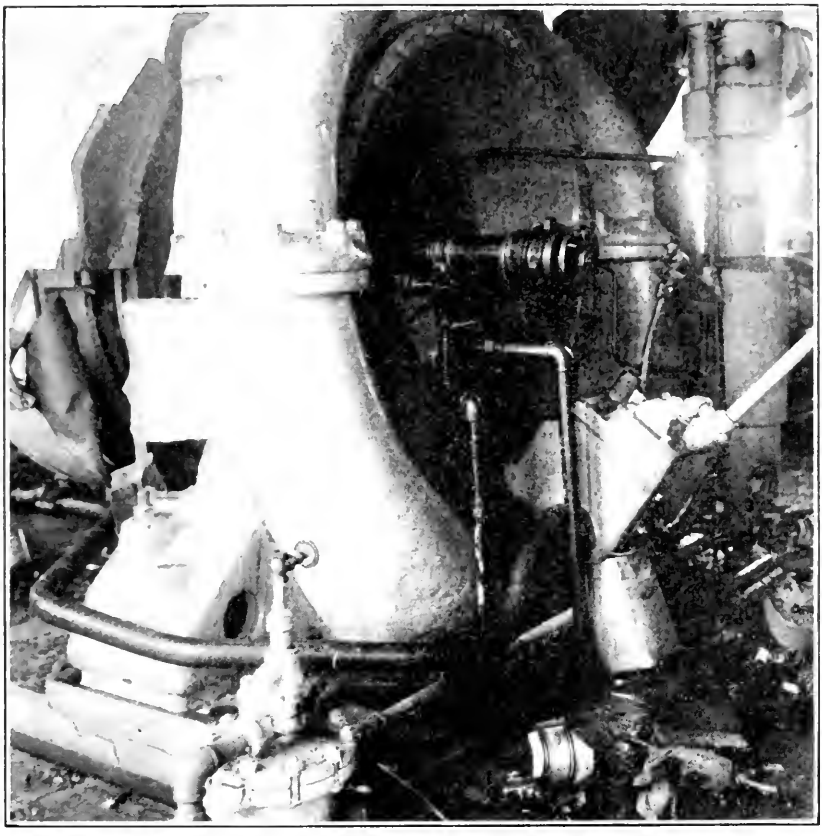
Figure 2

sudden drop in the a. c. voltage, accompanied by "hunting" on the part of the governor, the operator cut out the automatic voltage control and sought to correct matters by hand regulation. While he was thus engaged, the machine lost its load and he tripped the emergency governor to shut it down. At that instant the explosion occurred.

ings, supported on three bearings and fastened together by a rigid coupling. A fourth bearing supported the end of the exciter shaft which was joined to the outboard end of the generator shaft by means of a flexible coupling.

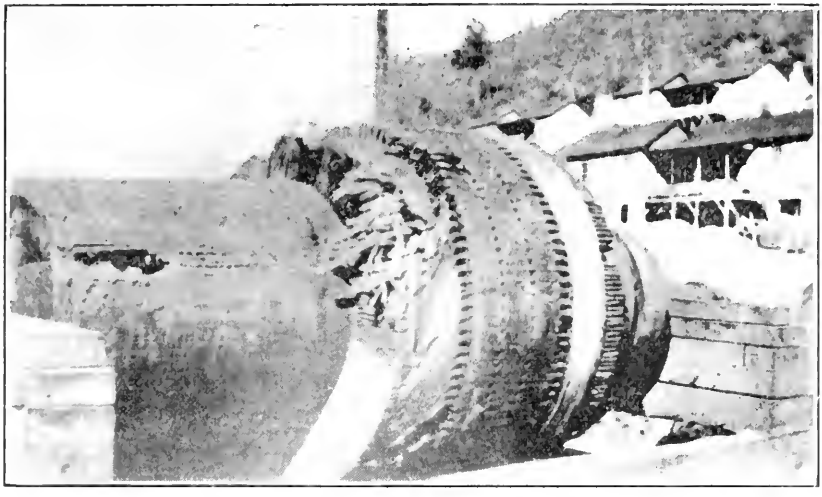
THE accompanying picture shows, in a fair degree, the extent of the damage caused by a breakdown of the armature of a 200-kw. rotary converter operating at 275 volts, 1,200 r.p.m., 3 phase, 60 cycles. It was the practice of this assured to attempt to blow out his rotary converters by means of a "hand bellows" instead of providing a source of compressed air for this purpose. Due to a lack of proper

air pressure as a result of the use of the hand bellows in cleaning, an appreciable amount of carbon and copper dust from the commutator brushes and collector ring brushes accumulated in the armature winding, or perhaps in the equalizers of the armature, and when a ground developed on the winding, the armature failed in many places as shown in the picture.

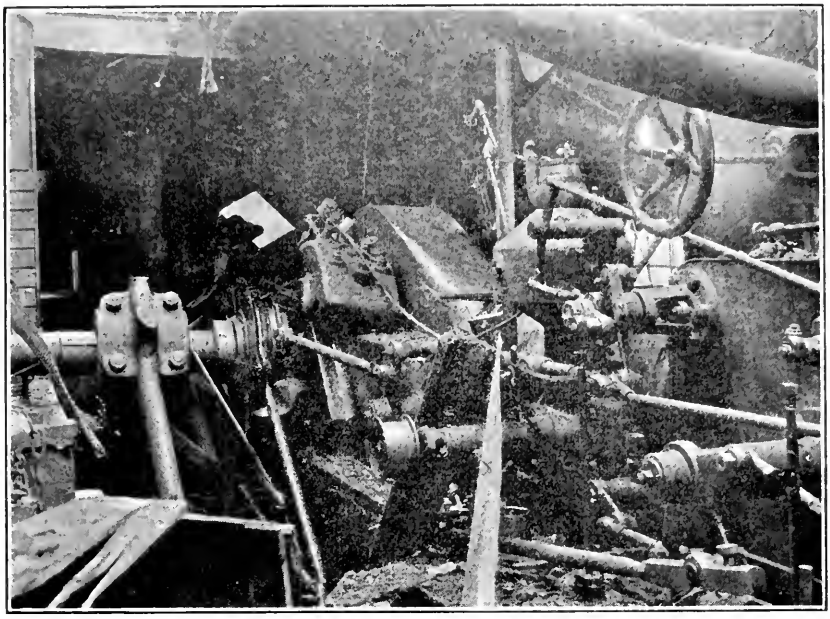
EXTENSIVE property damage was caused by a flywheel explosion on January 9th at the plant of the S. Austin Bicking Paper Manufacturing Company, Downington, Pa. The production losses sustained during the enforced shut-down following the accident must have been even more serious, for newspaper reports indicated that

The wheel was fourteen feet in diameter with a face of 36", and was in use on a Corliss-type engine of 350 hp. Circumstances seem to warrant the belief that the wreck was caused by breaking of the main belt and subsequent damaging of the governor mechanism when the broken end of the belt whipped around and struck it. Immediately prior to the wreck plant lights went out, apparently indicating that the generator, driven by the engine through a jack shaft and pulley from the main shaft, had stopped.

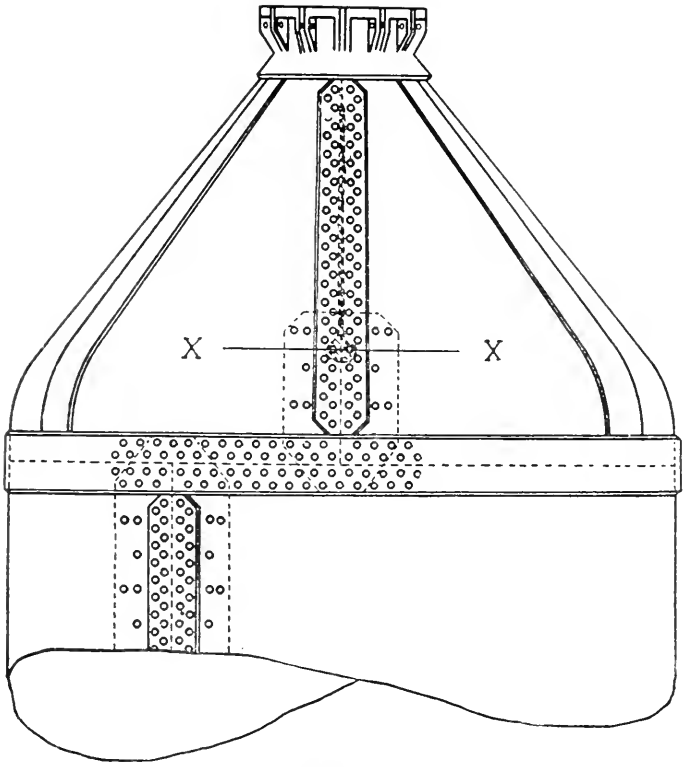
Figure 1

just opposite the center line of the butt strap joint, and at the height indicated by the line XX. Figure 2 shows the cross section at this point. The liquor penetrated the digester brick lining and the cement backing until it reached the inner butt strap. At this point some deterioration, although not extensive in area, occurred, but involved in this deteriora-

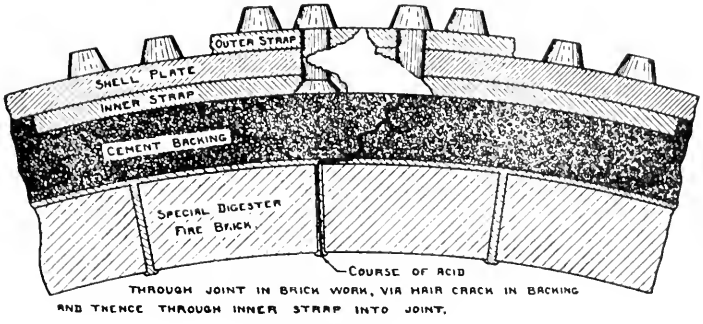
Figure 2

girth seam so that the cone top was still supported by the girth seam. However, had this leak occurred at one of the butt straps in the lining in the cylindrical shell of the digester, the corrosive action might easily have extended over the entire length of the course with resulting weakening of the structure which would, without doubt, have resulted in an explosion.

OUTER STRAP
SHELL PLATE
INNER STRAP
CEMENT BACKING
SPECIAL DIGESTER FIRE BRICK
COURSE OF ACID
THROUGH JOINT IN BRICK WORK, VIA HAIR CRACK IN BACKING AND THENCE THROUGH INNER STRAP INTO JOINT.

Visual inspection of the inside of the steel shell of the digester with the lining removed is of course most conclusive as indicating whether or not any corrosion has taken place. However, where such inspections

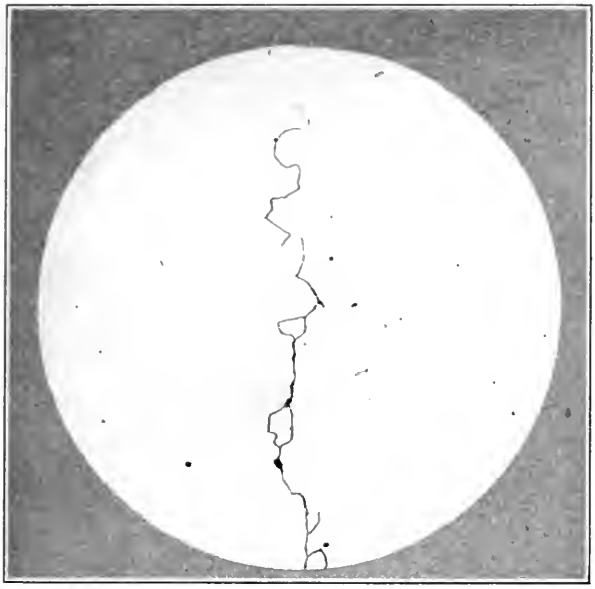
Figure 2

An actual photograph of an "embrittlement" crack magnified to 100 diameters. This gives an idea of the microscopic dimensions of the fissures which the inspectors find with the aid of the periscope.

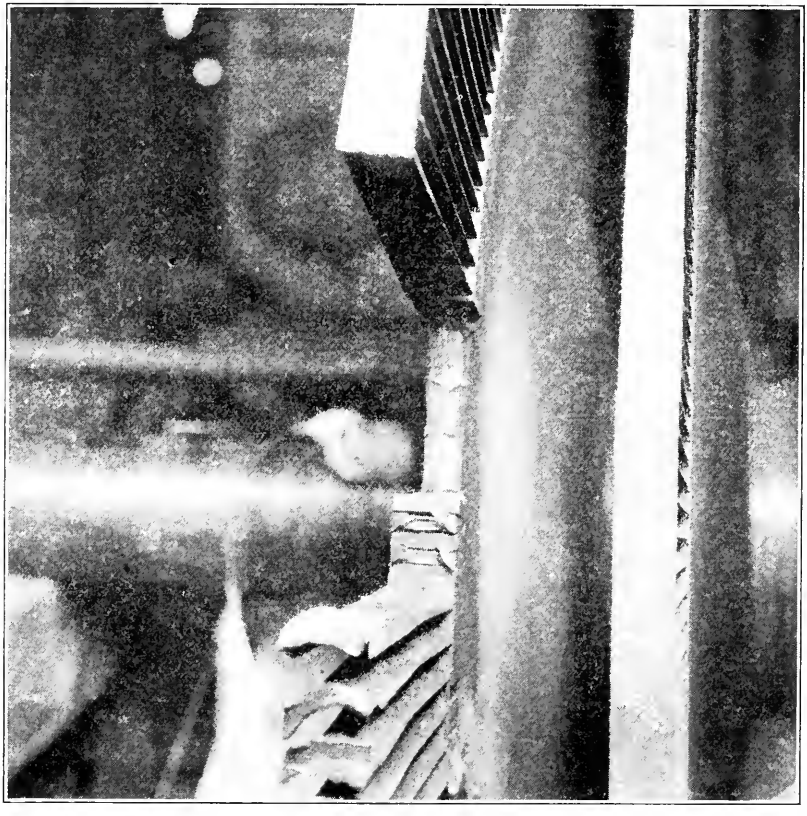
it under load again, had brought it up to speed and were testing the emergency device. Observers saw the emergency valve trip the instant the admission valve was raised. Simultaneously, however, there was a commotion inside the casing, accompanied by such severe vibration that the expansion joint in the steam connection between the high pressure and low pressure parts of the turbine distorted and ruptured.

In addition to the breaking of the disc, blades on another disc were loosened, the spindle bent, bearings broken, and the low-pressure casing damaged in several places. Pieces of metal went into the condenser and ruined about 60 tubes. The owner carried insurance in The Hartford Steam Boiler Inspection and Insurance Co.

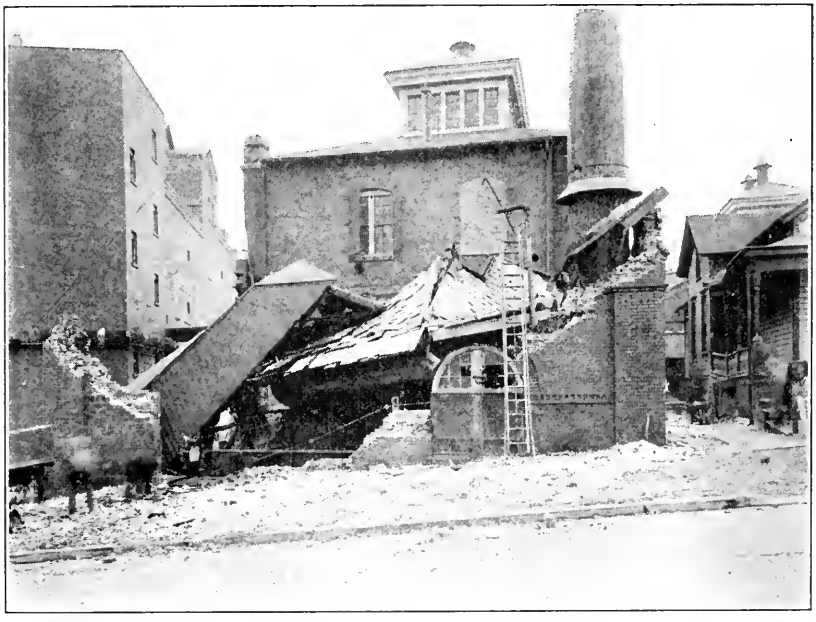
Although the building housing the boilers was practically destroyed, and all piping was torn down, only one of the three horizontal tubular boilers was damaged. That one sustained a dent when struck by a heavy timber.

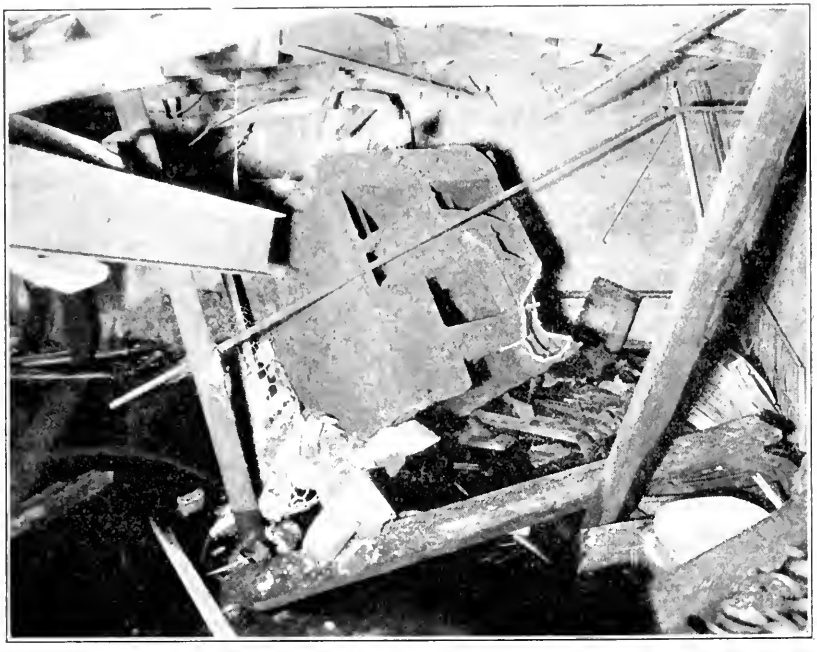
Figure 2

Aside from extensive damage to the marble stairway, shown in Figure 1, ironwork of the elevator shaft was bent, a large plate glass window was blown out of the bank, and several door frames and smaller windows were broken. Effects of the concussion were found as high

as the fourth floor, where window panes were shattered. Down in the basement piping, wiring, and equipment near the exploded heater were damaged extensively.

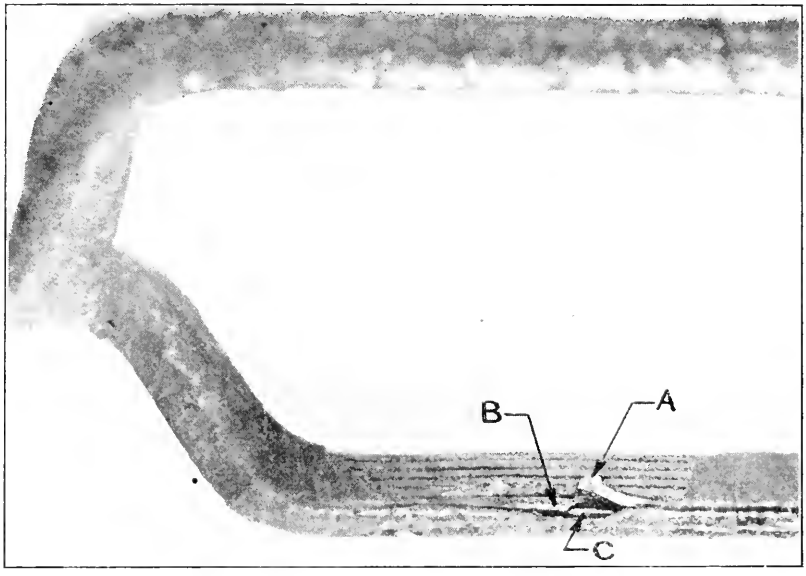
Figure 1

A stator coil from a small water wheel generator is shown in Figure 1, and the damage done was very nominal. The turns of this coil were made up of two conductors in parallel and the stroke of lightning grounded and burned in two one of the two parallel conductors of one of the turns, at a point several inches within the slot.

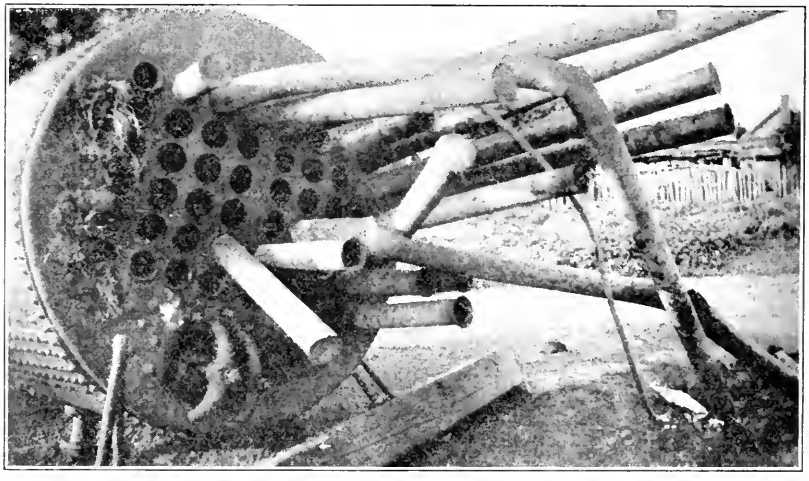
UNUSUAL, in some respects, was a recent accident at an Alabama planing mill where several tubes of a horizontal tubular boiler lost their grip in the front tube sheet and were blown entirely out of the boiler. It was said that some of the tubes had not been beaded and that on others the work had been done improperly. Two men were killed, the boiler house wrecked, and part of the mill damaged.

The accident occurred in the morning before the mill machinery was started up. There was little doubt that considerable over-pressure was present, even though the explosion ruptured neither the shell nor the tube sheets. When the front sheet bulged, after pulling away from three through stays and breaking another, the tubes pulled out and allowed steam and hot water to escape through the tube holes with terrific force. The two victims were caught in the path of this scalding flood and their bodies hurled 200 feet. Reaction shot the boiler backward about a hundred yards.

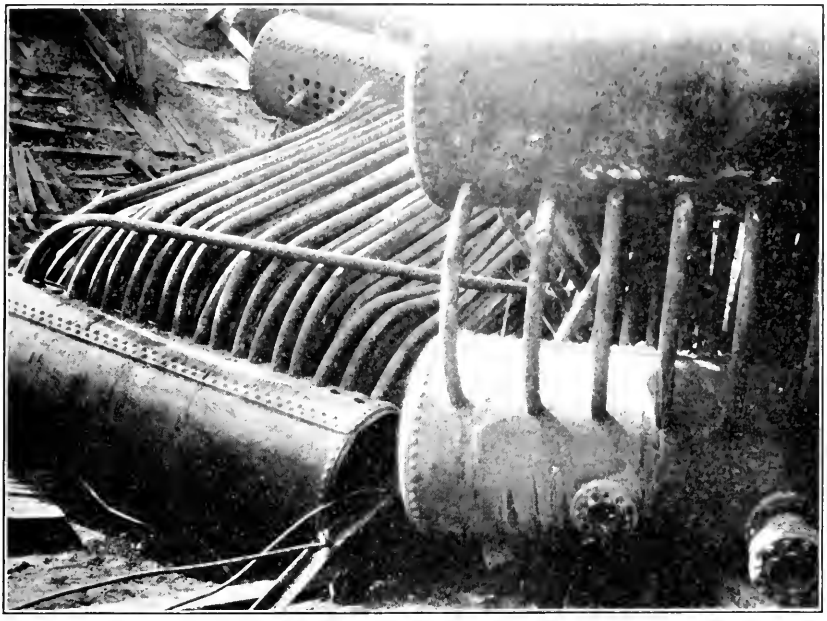
Figure 2

The style of setting used for the smaller boilers was such that the plain heads of their mud-drums were enclosed in masonry and were inaccessible for exterior inspection. An accumulation of soot, ashes, and moisture in the narrow space between the setting and the head that failed had led to considerable external corrosion, and the weak-

ening thus caused was further aggravated by the obsolete, somewhat flattened design of the head in which breathing action would produce flexing at the sharp turn of the flange.

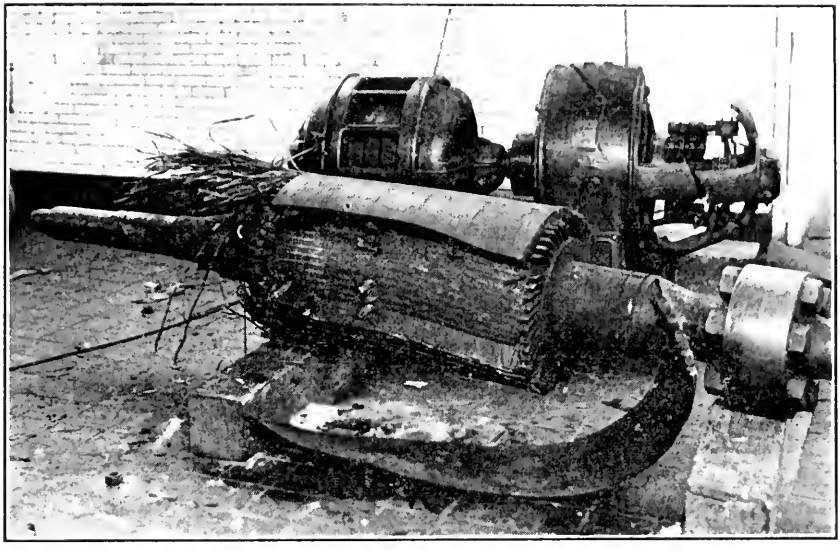
from one coil to another. As the breakdown of the mica was along a path 7/8" in length, it was evident that the normal exciting current at 125 volts could not possibly have been responsible for the trouble, and some other cause had to be found. It was finally located in the main oil switch for the generator, and was very simple. The oil switch mechanism had apparently not been adjusted properly. Burning had taken place on the contacts of one pole of the switch to the extent that they would not close. As a consequence the generator was being operated single phase or with unbalanced phase relations and under this condition there had been induced in the field a disturbance of sufficient magnitude to break down 7/8" of mica insulation.

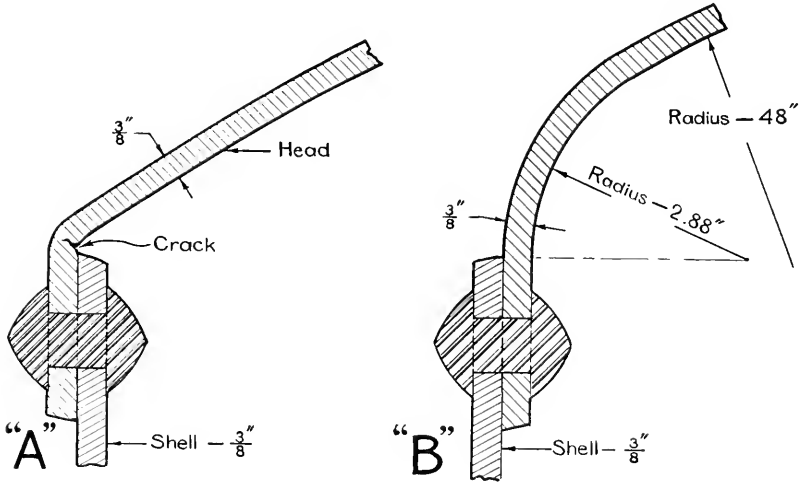
developed cracks from the inside surface at the corner of the head flange that weakened it to a dangerous degree.

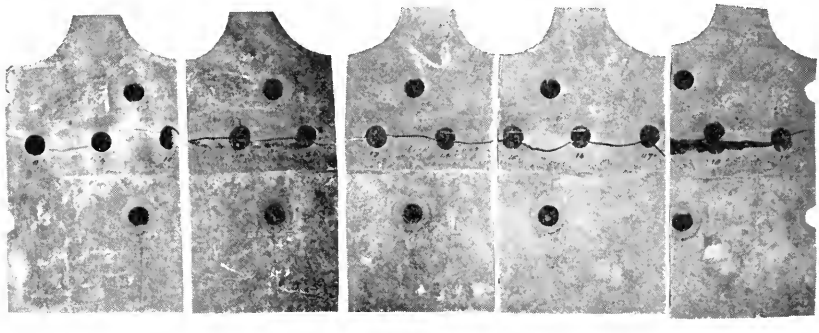
Figure 1

At one plant in the western part of New York state the drums of seven boilers of the Babcock and Wilcox cross-drum type were affected

so extensively that their continued use would have been dangerous. At another plant, located in Utah, six out of a battery of 14 boilers of the Stirling type had to be taken out of service.

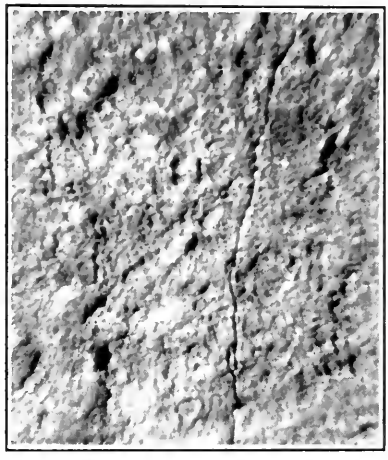
Figure 2

The first suspicion of the presence of embrittlement came in October of last year when one of the engineers happened to be present while workmen were removing the circulating plate from boiler No. 1. With the seam exposed, this engineer tried hammer testing a few of the rivet heads and found that he was able to snap two of them off. He reported the condition to the officials and they in turn asked the Hartford Steam Boiler Inspection and Insurance Company to send an inspector for a complete investigation.

One of the peculiarities of the case was that no signs of leakage could be seen at rivet heads or seams of any of the boilers in which rivets had been broken. However, after driving out the shanks of some of the broken rivets and polishing the walls of the holes with emery cloth, the inspector was not long in detecting several fine, hair-line cracks. Although invisible to the naked eye these cracks were clearly apparent under a magnifying glass.

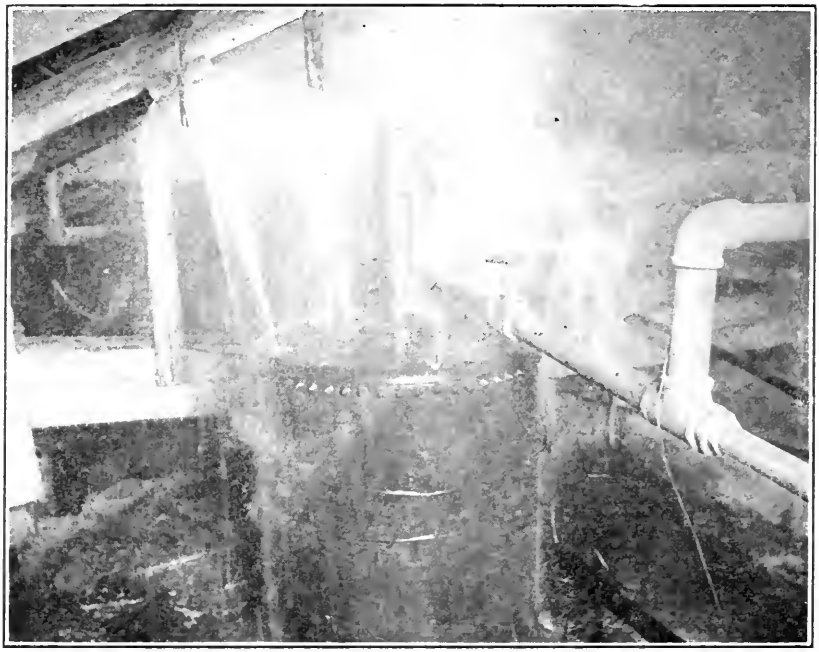
Figure 1

At another plant where there were eight water-tube boilers of the Stirling type set in pairs, the clue that led to the inspector's discovery of a serious condition was the finding of water in the inboard ends of

the upper drums of one of the boilers. This indicated that the drums had sagged down and led him to suspect that the supporting "I" beam between the boilers had either been warped by exposure to furnace heat or had deteriorated otherwise, a condition that could be expected to place an excessive strain on some of the blank drum heads to which supporting lugs were attached. Such proved to be the case, for the lugs of the middle drum blank heads were entirely clear of the beam, thus throwing all the inboard weight on the blank heads of the front and rear drums. Brickwork prevented an examination of the outer surfaces of the heads but by digging through a layer of hard scale inside the boiler the inspector uncovered an 18-inch crack along the turn of the flange beneath the lug of the blank head of the rear drum. The

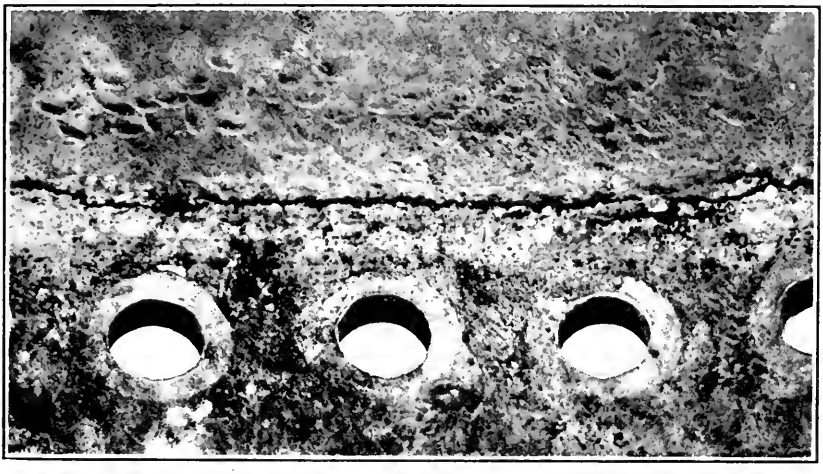
Figure 2

portion of the head containing the crack is shown in Figure 2. Similar cracks were found in the corresponding heads of three other boilers. It is not difficult to imagine what might have happened had these cracks not been discovered.

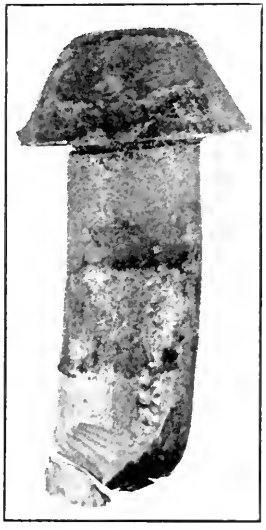
CAUSTIC embrittlement had nothing to do with the cracking of the rivet shown in the accompanying illustration, for it was found by an inspector during a recent shop inspection of a new boiler. The failure was attributed to stresses set up in the rivet shank directly under the head at the time of driving.

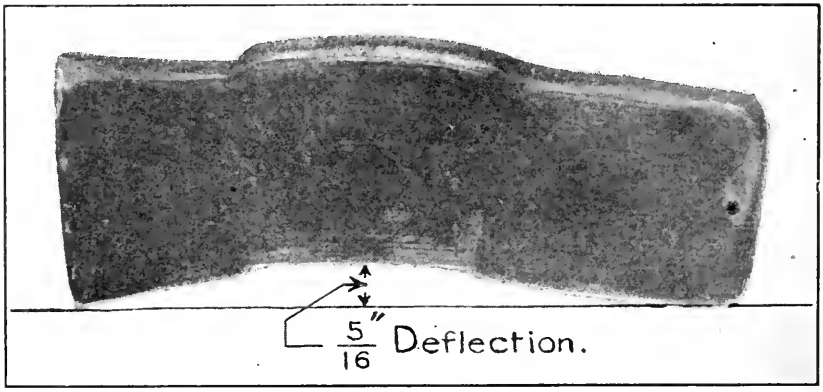
Figure 1

THE crosshead key shown below was bent due to water entering the low-pressure cylinder of a compound Corliss engine. The circumstances under which this occurred some years ago were rather unusual in that there was practically no other damage to the engine. As a rule when engine breakdowns occur from excessive water entering the cylinders the damage is quite extensive and often the engine is a complete wreck.

one evening it was noted by the operator that the last revolution of the belt wheel ended with a rather severe shock as if there were a sudden obstruction. He examined the engine and wheel for any possible damage but could not readily find anything wrong.

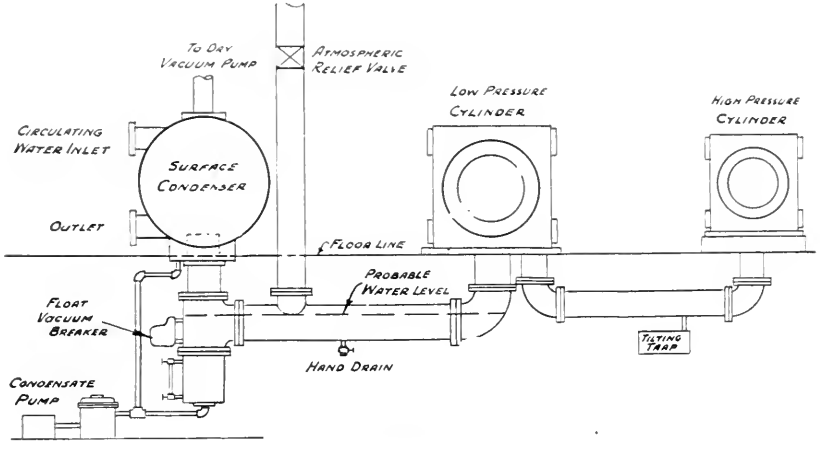
Figure 2

It was not immediately clear where the water could have come from but a careful check up of all the possibilities of the exhaust connections (shown in Fig. 2) made it evident that apparently water had accumulated in the exhaust pipe so that it may have reached a level as indicated by the dotted line. The float vacuum breaker must have stuck

closed so that it did not open earlier while the engine was still under load. The vacuum breaker apparently released itself or may have been opened by hand during the last few strokes of the engine. This allowed the water in the exhaust pipe to be driven into the low-pressure cylinder.

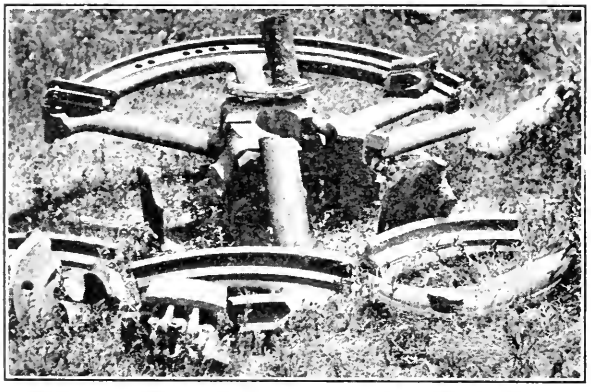
"When, for any reason, the lubricating oil so accumulates that the end of the rod strikes the surface, the oil is churned into a mist which, of course, is carried into the cylinder by the intake air. The engine governor has no control over the oil-charged air. Lubricating oil when mixed with air burns as readily as fuel oil. The faster the engine runs, the more the condition is aggravated, and the remaining oil in the crankcase is whipped into a fine mist and more of it taken in at each stroke. In a few seconds the speed may reach an exceedingly high point, resulting in a flywheel rim speed several times higher than the wheel was designed for as in the case cited above."

In the particular case under discussion the engine was totally wrecked, as was some of the mill machinery. The illustration shows broken parts of the wheel.

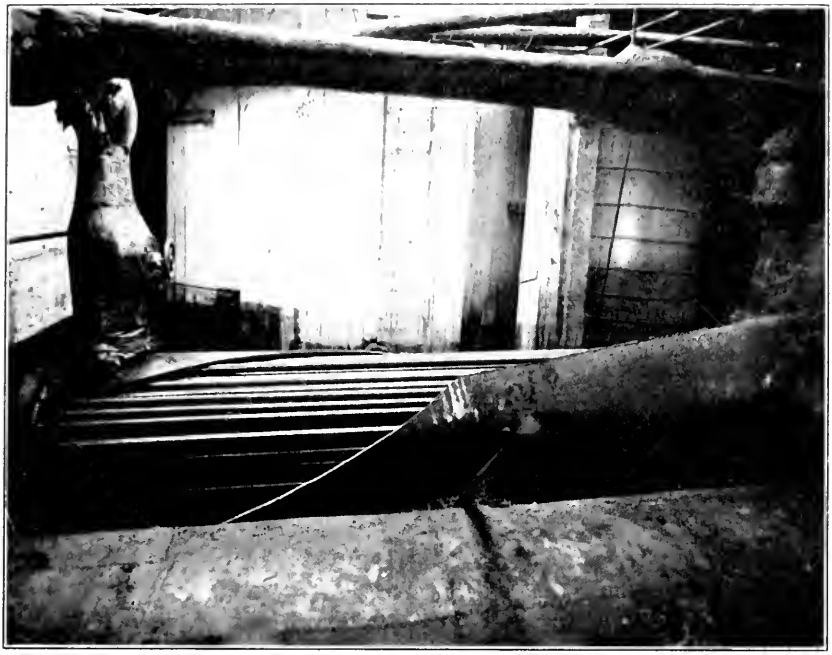
The brine cooler, which had been in use about twelve years, had a shell 42 inches in diameter and 16 feet long. Gas welding had been used in forming the longitudinal and girth seams, as well as for joining the ends of the shell to the cast steel tube sheets. Failure occurred by the tearing apart of one of the longitudinal seams, the break following along the seam for several feet before changing direction and going into the solid plate, as shown in the illustration. It was plainly evident that the welding had been poorly done. In fact, test coupons taken from another part of the seam after the accident were so weak at the point

of welding that they broke while under the slight pressure necessary to straighten them before they could be put into the tensile testing machine.

Because it was strongly suspected that the welded seams in several other vessels of the same age and make were in as poor condition as those of the exploded tank, the owners decided to replace them with others having riveted seams.

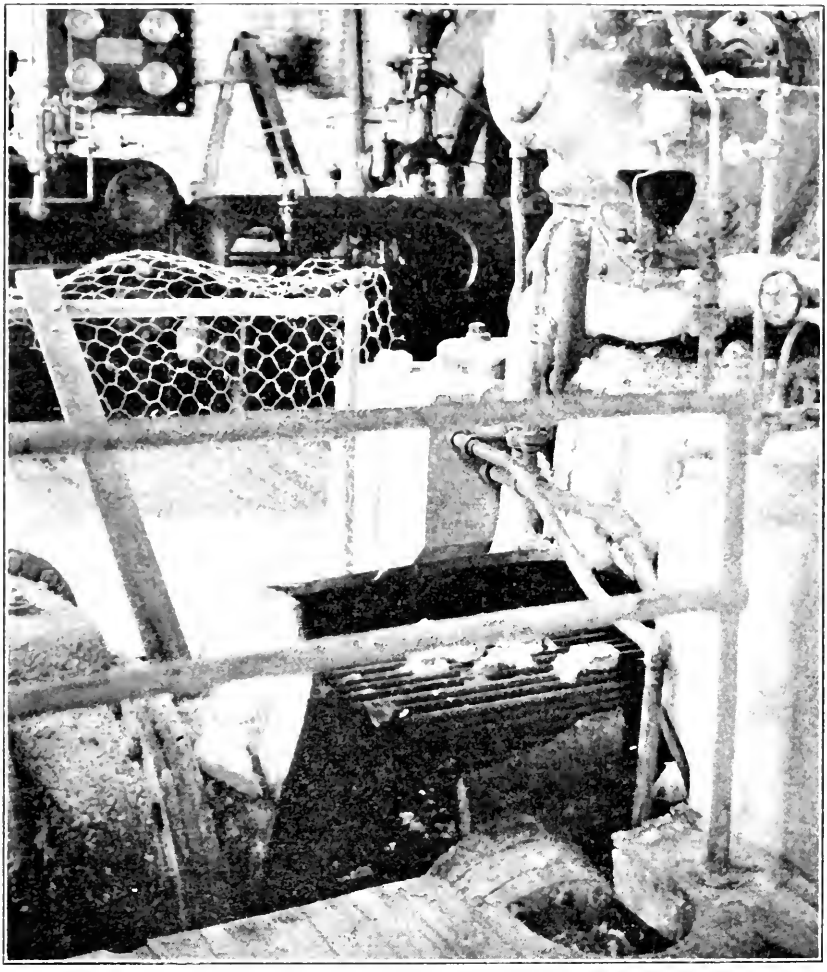
In the accompanying article the author stresses the need for frequent and thorough checks to determine the condition of all safety devices. The importance of this is clearly illustrated by the above photograph of a surface condenser explosion at a utility plant on December 6. The cause was, failure of the atmospheric relief valve to open when the circulating water was accidentally lost, the valve having been stuck closed.

A piece of the condenser shell weighing about 200 pounds was blown through a window, and the condenser tubes and copper expansion joints were bent so badly that they had to be renewed. If the flying piece of metal had struck the governor end of the turbine or the governing mechanism of the engine with the large fly-wheel shown in the picture the accident would have had much more serious consequences.

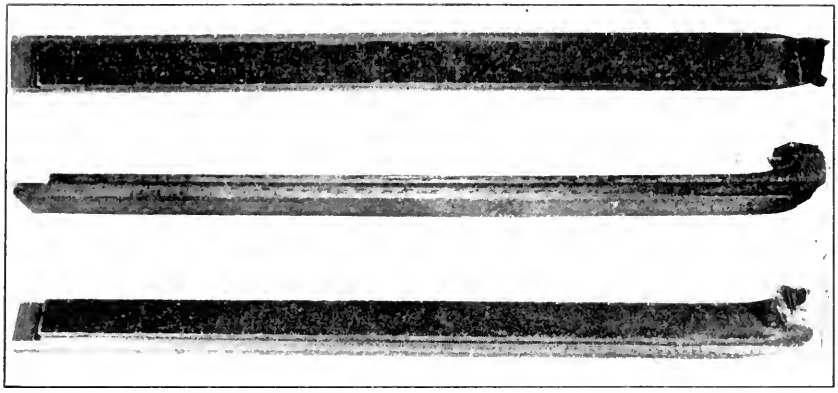
Figure 1

FROM time to time serious electrical troubles of an unusual nature, arise that may, in most cases, be foreseen and avoided by good engineering in operation and design of switchboard wiring. A more or less common cause of trouble of the nature under consideration is operating polyphase turbo-generators (having solid core rotors) with the current per phase unbalanced, and the extent of the

damage to the rotor as well as the time in which the damage occurs varies with the amount of unbalancing.

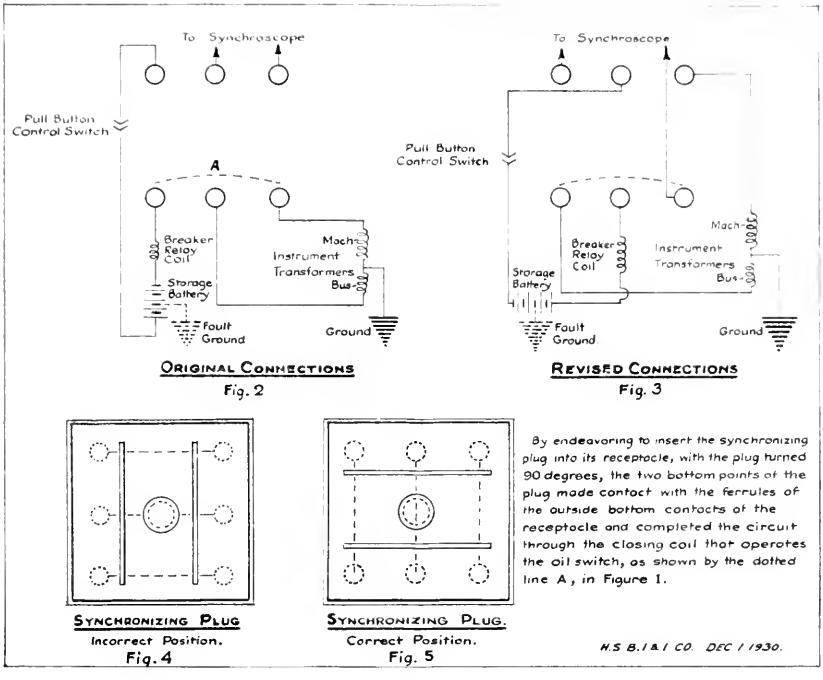
ORIGINAL CONNECTIONS
Fig. 2

To Synchroscope
Pull Button Control Switch
A
Breaker Relay Coil
Mach. Instrument Transformers Bus
Storage Battery
Fault Ground
Ground
To Synchroscope
Pull Button Control Switch
Breaker Relay Coil
Mach. Instrument Transformers Bus
Storage Battery
Fault Ground
Ground
By endeavoring to insert the synchronizing plug into its receptacle, with the plug turned 90 degrees, the two bottom points of the plug made contact with the ferrules of the outside bottom contacts of the receptacle and completed the circuit through the closing coil that operates the oil switch, as shown by the dotted line A, in Figure 1.
N.S.B.I.A.I. CO. DEC. 1930.

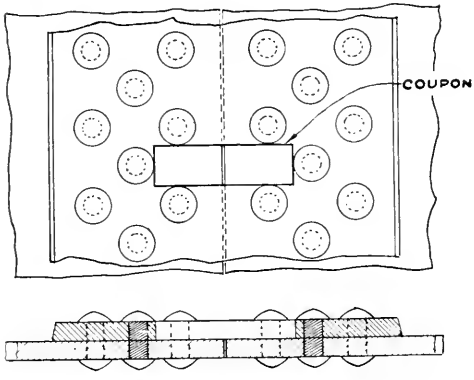
Figure 1

THE wood pulp digester explosion at Berlin, New Hampshire, late in 1930, which resulted in the death of two men, the serious injury of five people and a total loss reported to exceed $350,000 emphasized the immense amount of energy (approximately equal to 500 lbs. of T. N. T.) stored in such a vessel under usual operating conditions. It also served as a reminder of the fact that in the operation of a digester a thin brick-cement lining of unknown condition and a thin steel plate of unknown condition and material, are the only bars to death and destruction.

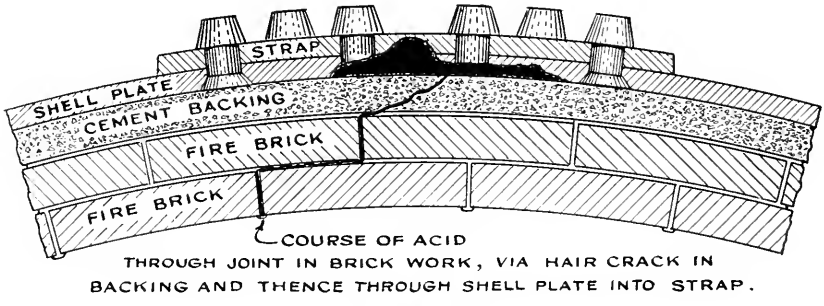
Figure 5

was similarly grooved, and corroded to a less extent over a considerable area as indicated by the sketch in Figure 5.

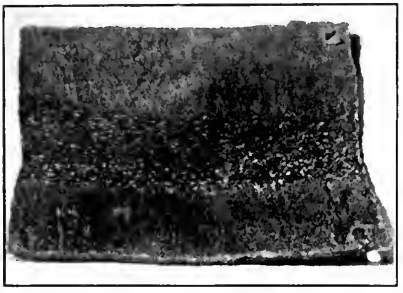
Figure 6

Soda and sulphate digesters are unlined, for the liquor is presumed to be alkaline and thus non-corrosive. However, while this investigation was not primarily intended to include digesters of that kind, it led to the discovery of several which had been weakened to a dangerous extent as the result of corrosion at the head flanges or adjacent to forge welded seams. While the stresses due to the fabrication of the vessel made the material susceptible to the effects of fatigue corrosion, there was also a decided appearance of an acid action. A photograph of a seriously affected section of a sulphate digester is reproduced in Fig. 6.

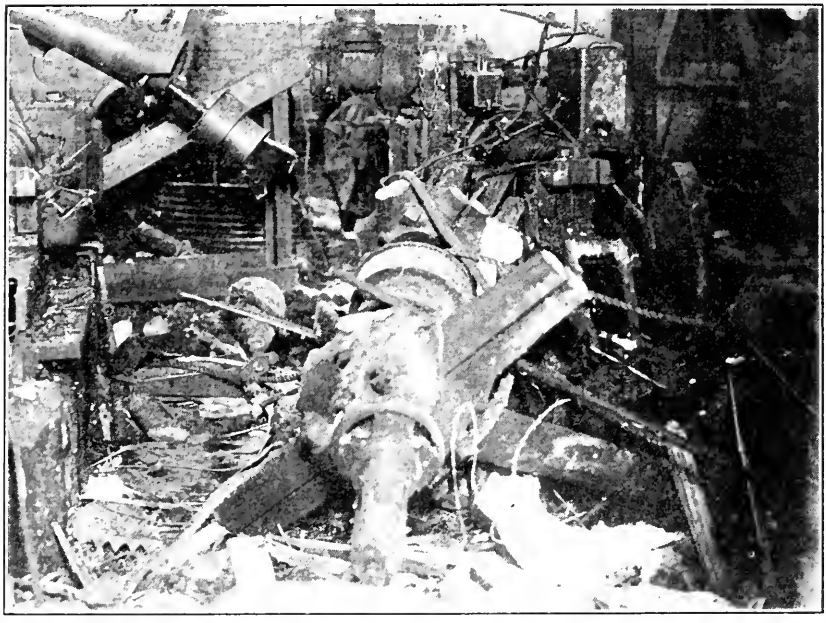
THE accompanying illustration is a picture of the wreckage of a paper making machine engine after overspeed exploded both the balance wheel and the rope wheel. The engine shaft was ripped out of the bearings and, with the exception of the cylinders, the machine was completely demolished. Flying parts damaged the building, other machinery and stock in process.

An investigation after the accident led to the conclusion that the trouble started by breaking of the belt between the two cone pulleys. This threw the engine out of control of the governor and allowed it to

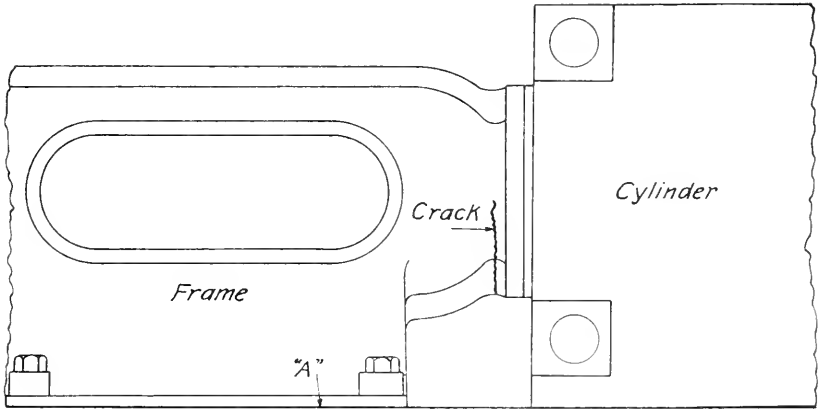
Fig. 1. Characteristic Crack Formation in Engine Frame

acteristic location for these cracks is in the frame neck near the cylinder as shown in Fig. 1, although they may occur also at the crank end of the guide barrel. The origin of such cracks is almost invariably to be found in the sagging of the frame when the grouting under it becomes soft locally due to oil which may be spilled over the foundation. Concrete becomes quite soft and compressible after long contact and saturation with oil.

The most likely place for the grouting to become soft due to oil saturation is at "A" in Fig. 1, as it is at this point that usually a small amount of oil is thrown out of the guide barrel by the crosshead at every revolution of the engine. After some years of operation under these conditions it becomes noticeable that oil is pressed out from under the frame at point "A" when the crosshead moves over that end of the guide barrel, and is sucked in again as the crosshead moves toward the crank end. When this occurs it should be clear that the engine frame is not being properly supported at point "A" because the grouting has become soft and compressed. The consequence is that the downward force acting on the guide barrel is transferred through the frame neck to the nearest support under the cylinder and this produces a bending action in the frame neck which may eventually result in a crack. After a small crack is once started it takes but a short time for it to run half way or even
